HCM Contractors and RWH Engineering – A Model For Success

By Jason Weck, MEng, PEng, Vice President, HC Matcon Inc. and Kailey DenBraber, EIT, RWH Engineering Inc.

Project Summary

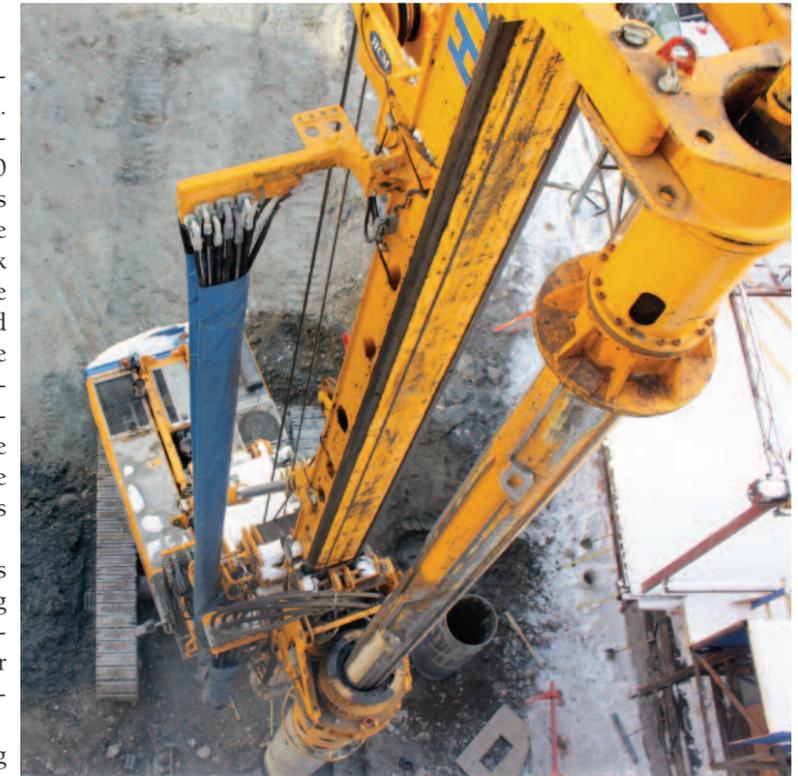
Figure 1 - Bauer BG24 piling rig.

The construction of the shoring system began on October 2013 with the installation of the secant caisson wall. Three Bauer* BG24 rigs were used to employ 34 inch diameter sectional casing in order to drill through 20 to 30 ft of gravel overburden consisting of cobbles and boulders and existing building foundations. Refer to Figure 1. The piles were socketed a minimum of 10 ft into the bedrock and the toes were enriched with cement to increase the concrete strength to 2200 psi to increase the strength and stability of the pile toe. Fillers were extended 3 ft into the rock to help minimize groundwater seepage into the excavation. A three filler caisson wall sequence was followed, installing W21x55 piles on 9.5 ft spacing. The drilling was carefully scheduled to install over 500 pile and fillers, while ensuring the correct sequencing was maintained.
